**CRAIG CROTTY
ARBOR CULTURE LLC**

October 5, 2016

RE: Observations and comments regarding trees located at 824 S. Gladys Avenue

ARBORIST STATEMENT

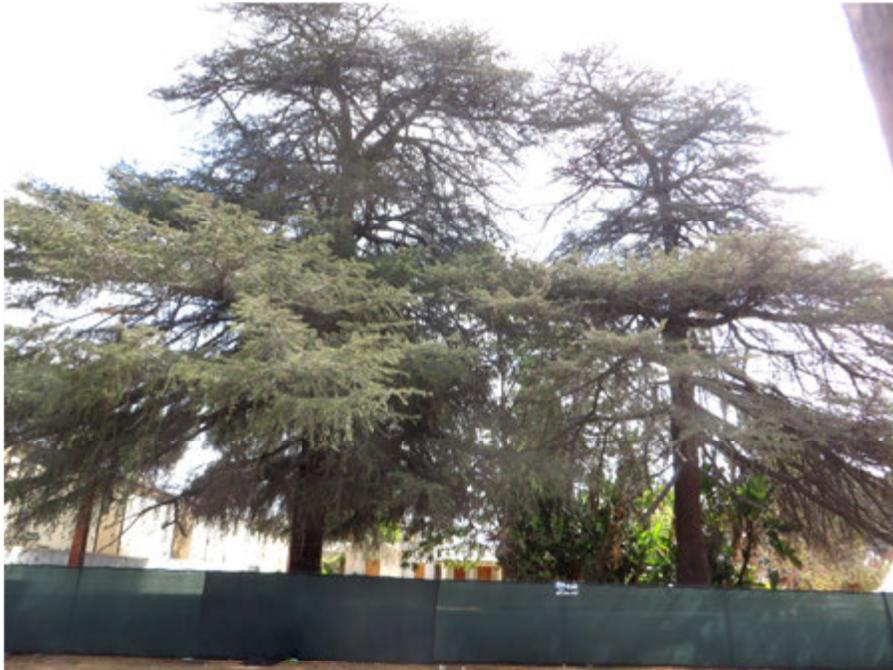
The current condition of the large Cedars is rated as fair due to severe drought stress. The site has apparently laid vacant for a considerable period with no irrigation near the trees combined with a years-long ongoing regional drought. These trees are alive but need regular maintenance primarily in the form of sufficient irrigation. Drought has also caused a build-up of deadwood in the trees. Crown cleaning pruning to remove dead, dying, and broken branches is needed.

The large landmark Deodar Cedar trees in the NW corner are recommended for preservation. They need irrigation soaking now and crown cleaning to remove dead branches.

Regular maintenance irrigation is needed now to keep the Cedar trees alive. They should be watered deeply now and once a week thereafter before and during construction. They are full of accumulated deadwood and should be pruned by crown cleaning before workers populate the site. Further, construction and roadway paving should be held back a safe distance from the trunks in order to protect the root zones.

- Cedar trees should be deep watered within their driplines but not on the base of the trunk. Hold back irrigation water eight feet minimum from tree trunks. Begin maintenance watering as soon as possible.
- Crown cleaning pruning to remove dead, dying, and broken branches is needed.

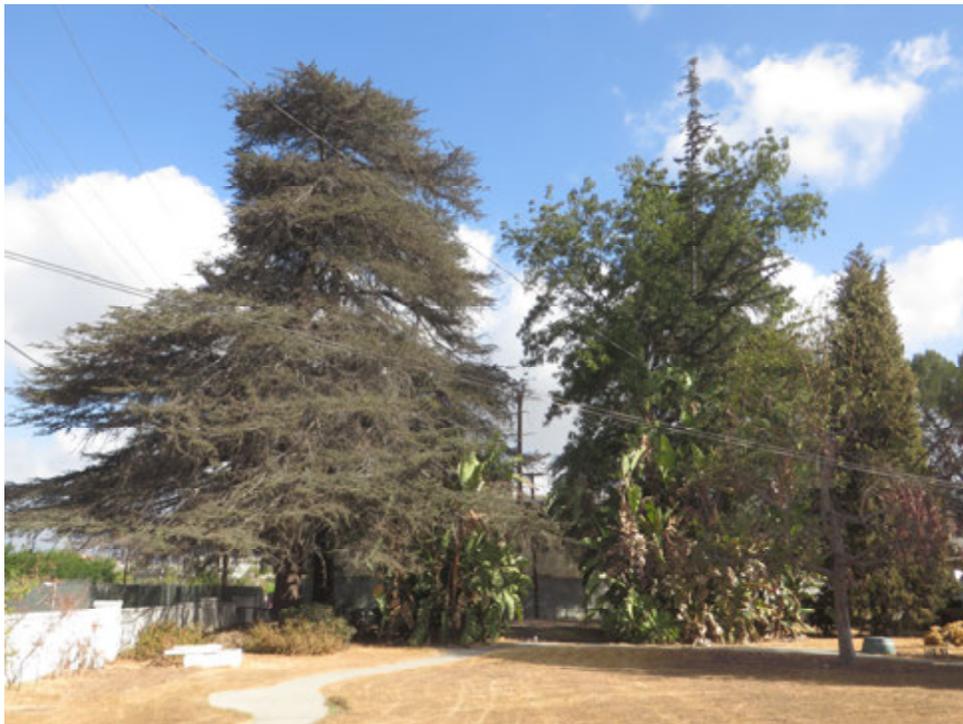
Looking north the Cedar trees should be deep watered within their driplines but not on the base of the trunk. Hold back irrigation water eight feet minimum from tree trunks.

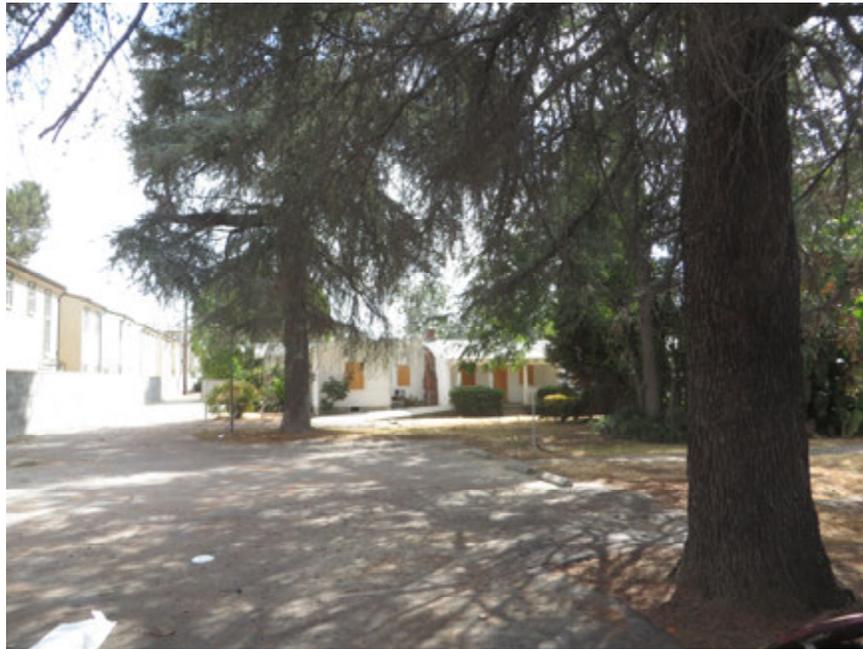
There is a planned perimeter roadway around the new complex. A paved road currently exists along the north side of the site near Cedars #1 and #3. At this point it is unclear exactly how wide the new road will be required by the Fire Department. These are large trees, to protect the roots zone the best case recommended distance to hold back pavement would be:

#1 Cedar (front) and #3 Cedar (center) may be encroached by excavation and compaction for a new roadway/fire access. Best case is to keep new grading and paving +/- 15 feet from the tree trunks.

- #1 Cedar-36 inches dia.-hold back pavement 15 feet.
- #3 Cedar-34 inches dia.-hold back pavement 14 feet.

If these distances are not possible due to fire mandates, we may need to look at alternative pavements within the protection zones. This might include paving stones meandered around the trees on less compacted than usually required base material. Soil compaction reduces permeability and kills absorbing roots as one of the primary killers of trees on construction sites.

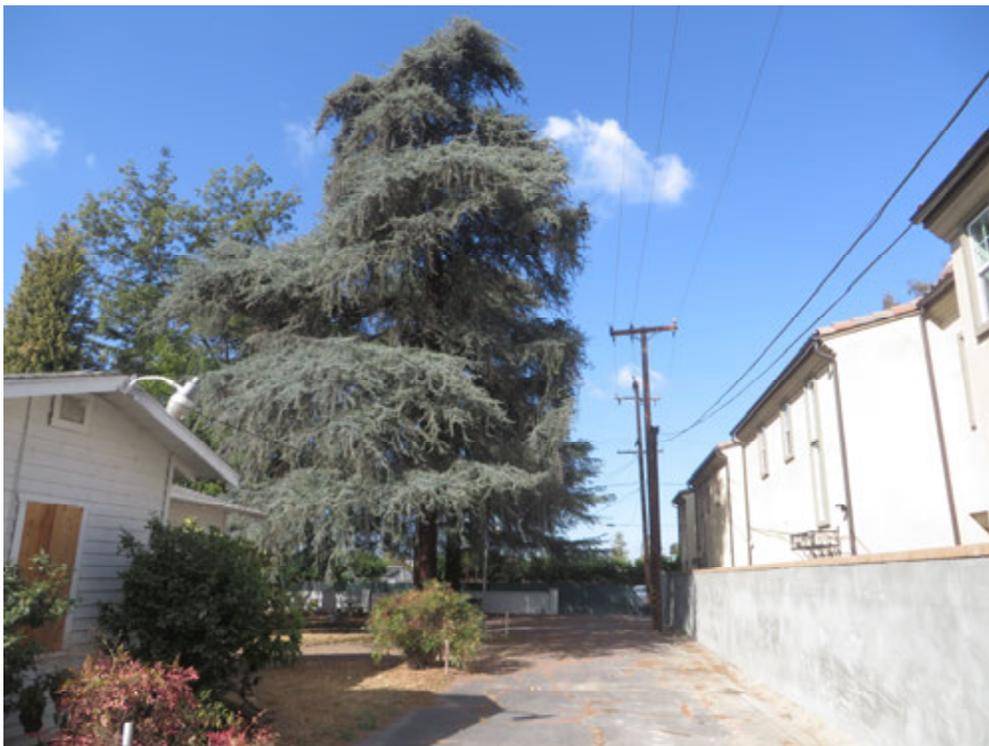
Looking west along the north property boundary, the existing road width may need to be widened.

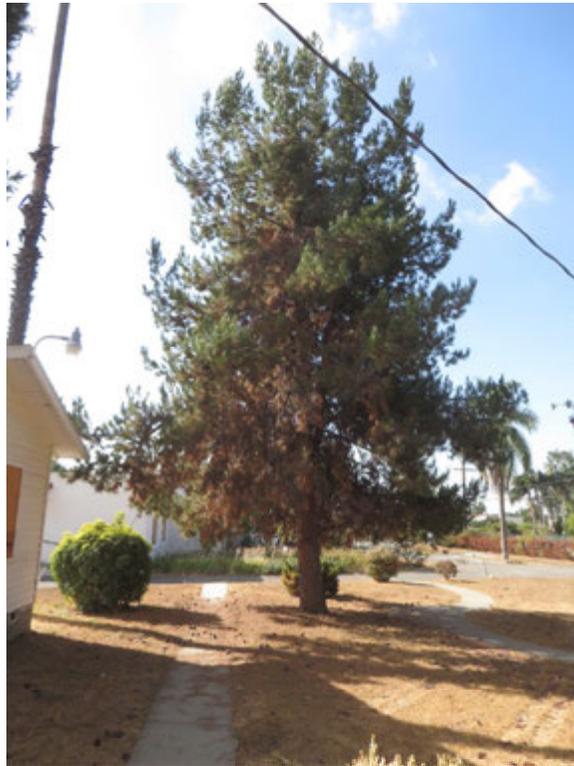
#6 Mondell Pine is an example of a tree to be removed and mitigated.

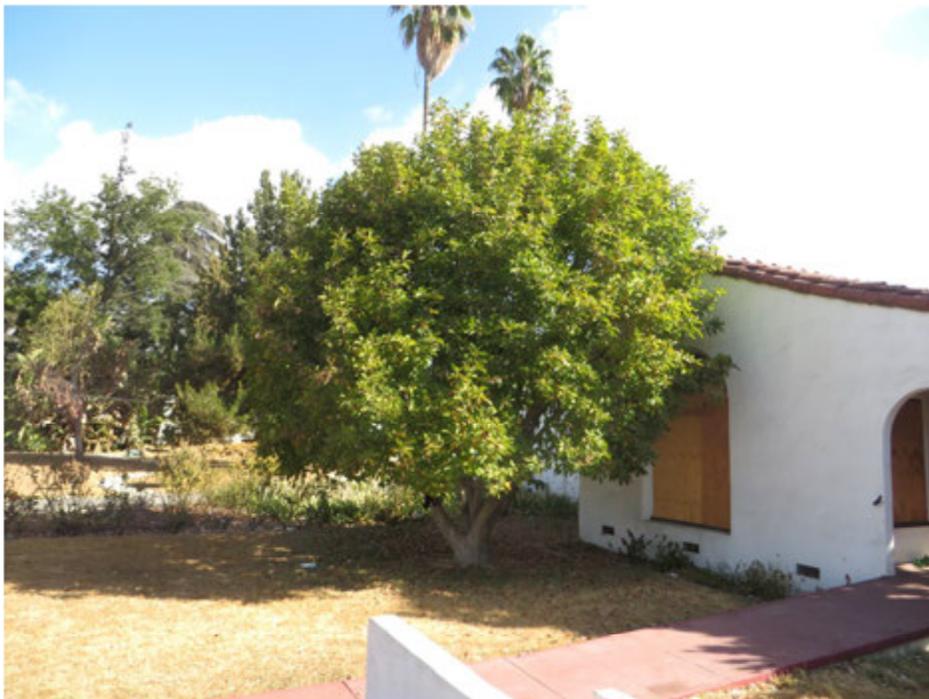
#13 *Magnolia soulangiana*, Saucer Magnolia is a quality 30 inch diameter specimen tree that could be subtracted from the above diameter inch totals if the developer wants to consider relocation. This is a well formed, high quality, and healthy specimen tree that may be worth considering for relocation.

#13 Saucer Magnolia, 30 inches diameter at grade could be relocated on site if so desired.
