**CRAIG CROTTY
ARBOR CULTURE LLC**

October 5, 2016

RE: Observations and comments regarding trees located at 824 S. Gladys Avenue

ARBORIST STATEMENT

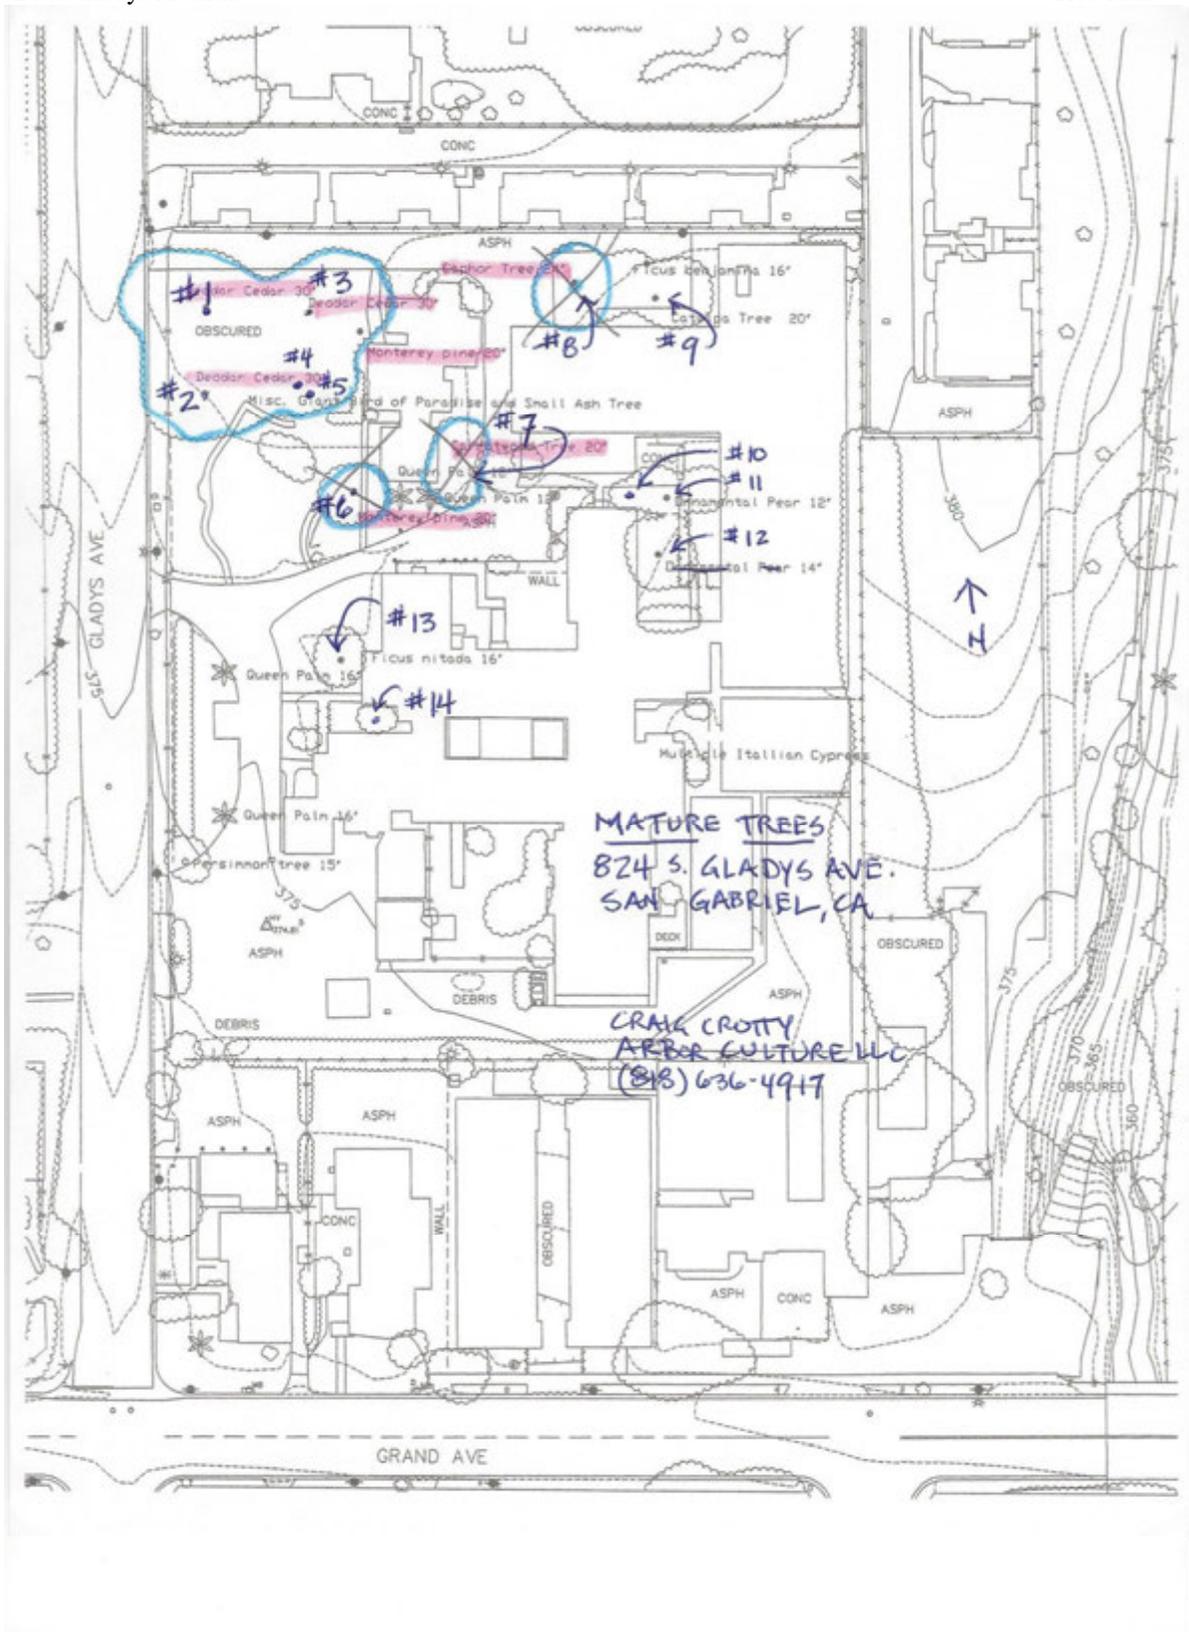
The current condition of the large Cedars is rated as fair due to severe drought stress. The site has apparently laid vacant for a considerable period with no irrigation near the trees combined with a years-long ongoing regional drought. These trees are alive but need regular maintenance primarily in the form of sufficient irrigation. Drought has also caused a build-up of deadwood in the trees. Crown cleaning pruning to remove dead, dying, and broken branches is needed.

The large landmark Deodar Cedar trees in the NW corner are recommended for preservation. They need irrigation soaking now and crown cleaning to remove dead branches.

- Cedar trees should be deep watered within their driplines but not on the base of the trunk. Hold back irrigation water eight feet minimum from tree trunks. Begin maintenance watering as soon as possible.
- Crown cleaning pruning to remove dead, dying, and broken branches is needed.
